AMMRC TR 80-15

CHARACTERIZATION OF TURBINE CERAMICS AFTER LONG-TERM ENVIRONMENTAL EXPOSURE

GEORGE D. QUINN

Date Published - April 1980

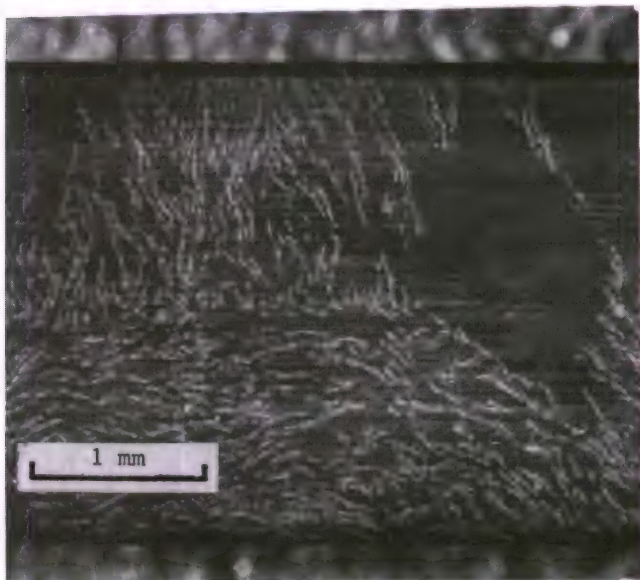
Figure 9. Light photo of the flat surface of an NC 136 bend sample showing the mottling. The surface is as machined.

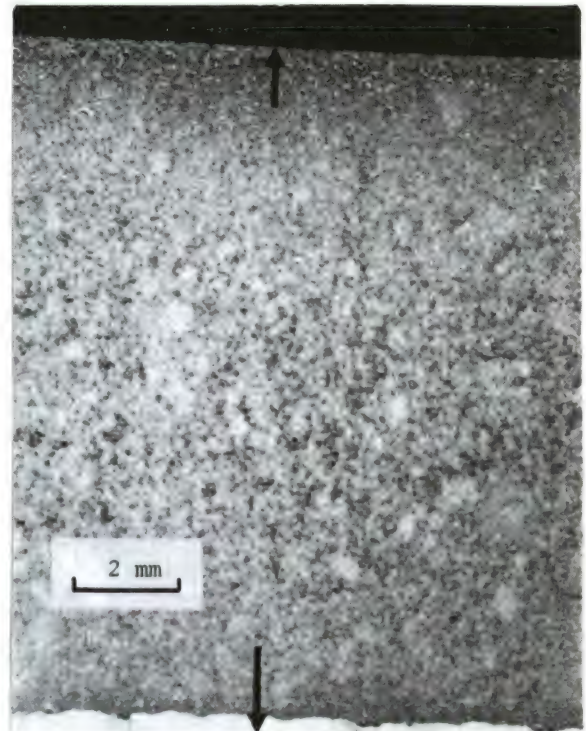
Figure 12. A light photograph of a section through the thickness of a KBI RBSN billet. The two arrows mark the surfaces. The billet is 1.27 cm thick (arrow tip to arrow tip). The gradient in porosity is evident.

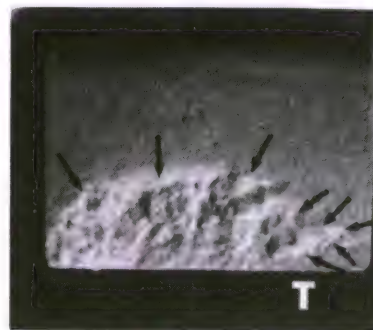
h. 270 MPa at 110 hours

Figure 30. Fracture surfaces showing slow crack growth at 1200 C in NC 132. Arrows outline the SCG zones. T denotes the tensile edge.

Fracture surfaces showed prominent slow crack growth zones (Figure 30). Outside of the SCG zone, fracture surfaces were relatively smooth and not jagged. The samples generally broke into only two pieces. As will be shown below, a Griffith criterion of failure may account for the enormous size of these flawed areas, but as discussed in References 43, 46, and 47, the notion of an ideally sharp crack propagating through the material is unrealistic. In general, the longer the time to failure, the larger the SCG zone. The short-time-to-failure samples (Figure 30a-f) had a semicircular (or quarter circle from the corner) SCG shape. This shape gradually evolved sideways under the influence of tensile stress, first to an ellipse and then to a linear crack front as additional time elapsed prior to failure. SCG zones were observable in samples which endured more than 10 minutes, but samples which failed in less than that time showed no prominent SCG zone and instead assumed a fast fracture-like appearance (smooth mirror - jagged fast fracture zone). In at least one case, two independent SCG zones grew on the same fracture surface. While in some samples the SCG grew from a corner, at least half of the samples had SCG growing from a location either on the tensile edge or internally.

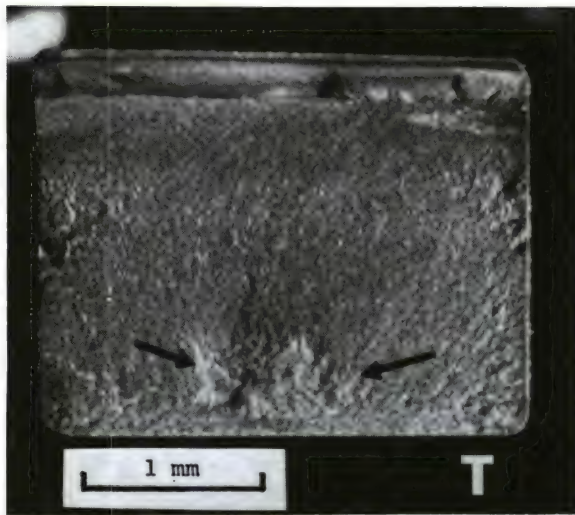
a. Light photomicrograph for a fracture surface of a sample which survived 247 MPa for 330 hours.

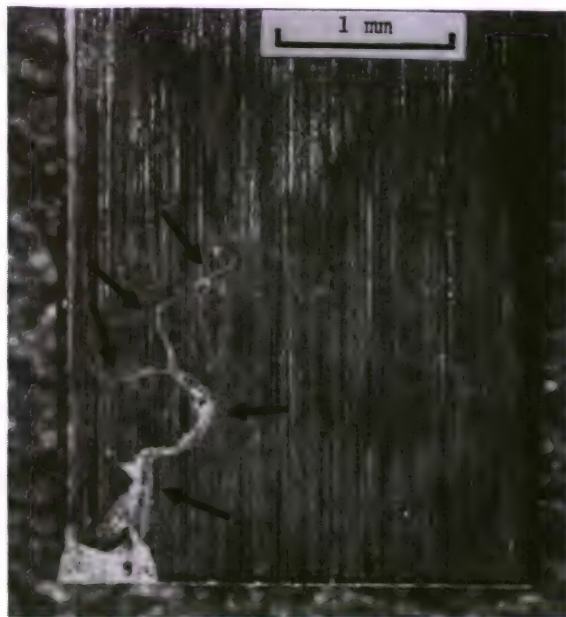
a. Light photo of the flat surface of an NC 136 bend bar showing processing cracks (arrows). This particular sample was fractured at the other end of the piece.

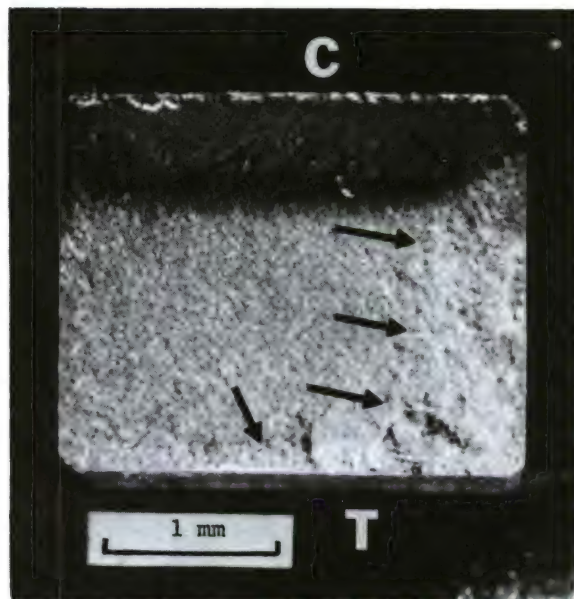
Figure 56. Fracture surface of the sample shown in Figure 55. Cracking extends along the tensile face and up the side of the sample (arrows).

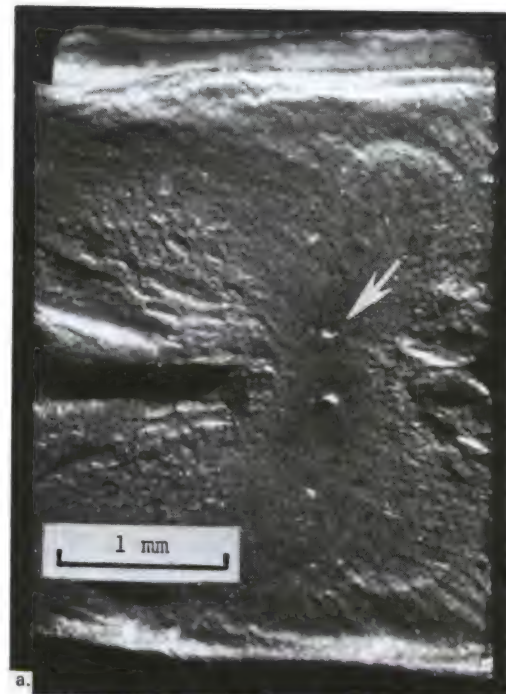
Figure 84. (a) Matching fracture halves for a control sample that broke at 273 MPa; (b) SEM close-up of the strength-controlling defect. The defect appears to be a porous region with inclusions or free silicon. The shapes of some of the features (arrows) suggest a melting effect.

Failure initiation sites were often readily indicated by mirrors as shown in Figure 84. Unfortunately, the strength-controlling defects of the three lowest strength samples were not identifiable. Two of these failed from corner sites and one of them might have failed from a corner machining chip. The higher strength samples failed from pores or defects associated with pores (Figure 85). Often the defects appeared like white inclusions when viewed with the light microscope. When examined by SEM, however, these zones were revealed

to be porous regions (Figure 86). Several samples had features that appeared to be inclusions but may be silicon pockets associated with porosity (Figure 84b).

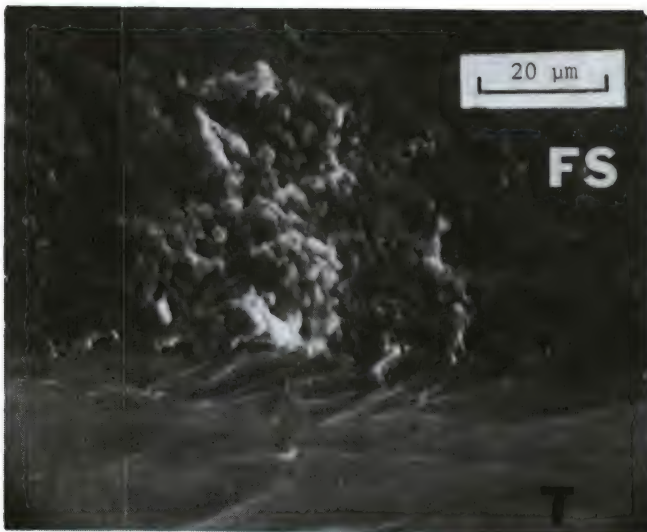
Figure 88. SEM close-up of the defect that caused a Ford 2.7 RBSN sample to fail at 0.9 hour at 1200 C. The defect is a surface-connected porous zone. A smooth oxide layer seals the surface.

(Figure 88) and one from a corner pit-pore. The fourth, 0.028 hour at 228 MPa, shattered into many pieces on failure. All but the failure-on-loading samples had oxide layers that sealed over most porosity (Figure 88). The oxide was identified by X-ray diffraction as alpha cristobalite.

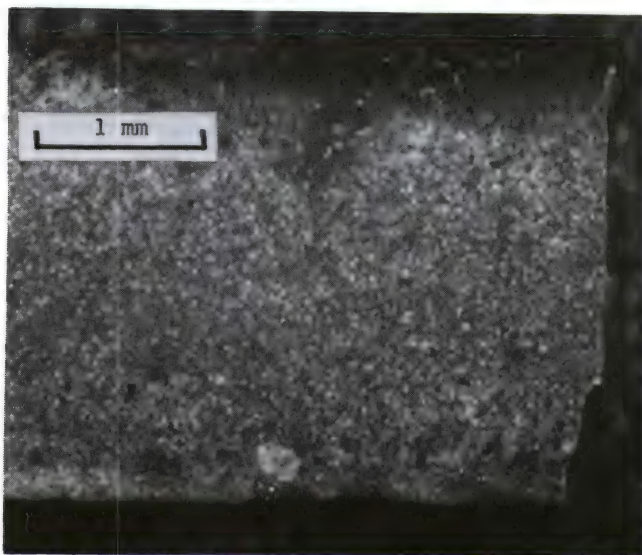
Figure 94. Light photo of the exposed surface of a combined cycle sample of Ford 2.7 RBSN.

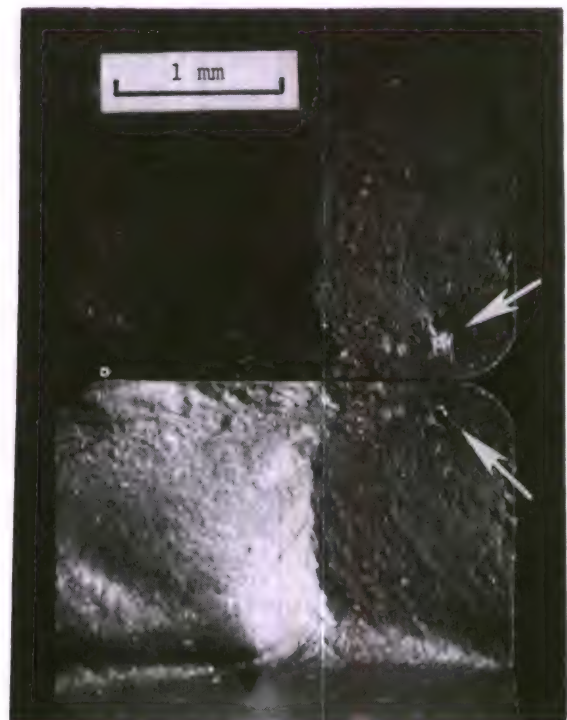
Figure 97. The only Ford 2.7 combined cycle sample with a subsurface defect that controlled the retained strength. Fracture stress was 195 MPa.

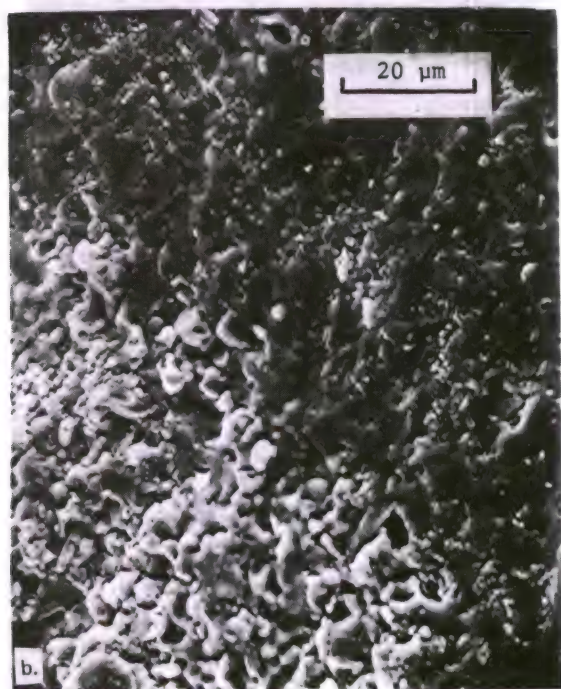
Figure 113. (a) Fracture surface of a Carborundum 1977 SiC STSR sample. An elliptical slow crack growth zone is evident; (b) SEM close-up of the boundary of the elliptical zone. Crack growth inside the zone is intergranular; outside the zone (the half with the size marker) the crack traveled transgranularly.

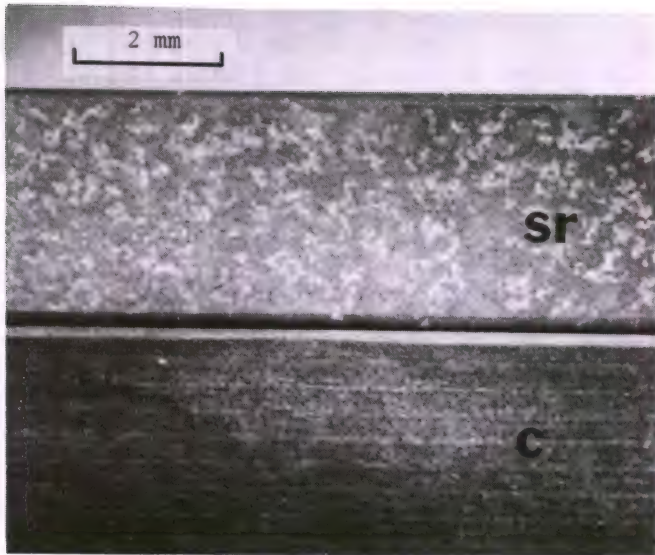
Figure 132. Light photomicrograph of the surface of a 300-hour NC 433 stress rupture survivor (sr) adjacent to a control sample (c).

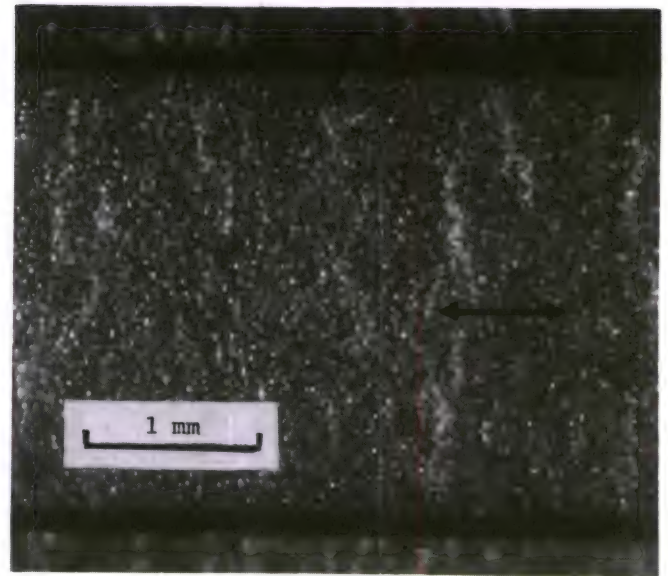
Figure 139. NC 435 STSR sample that was loaded to 296 MPa and failed at 22 hours at 1300 C. The flat tensile face is shown and lateral creep cracks are evident. Tensile bending stresses were in the direction indicated by the double arrow.

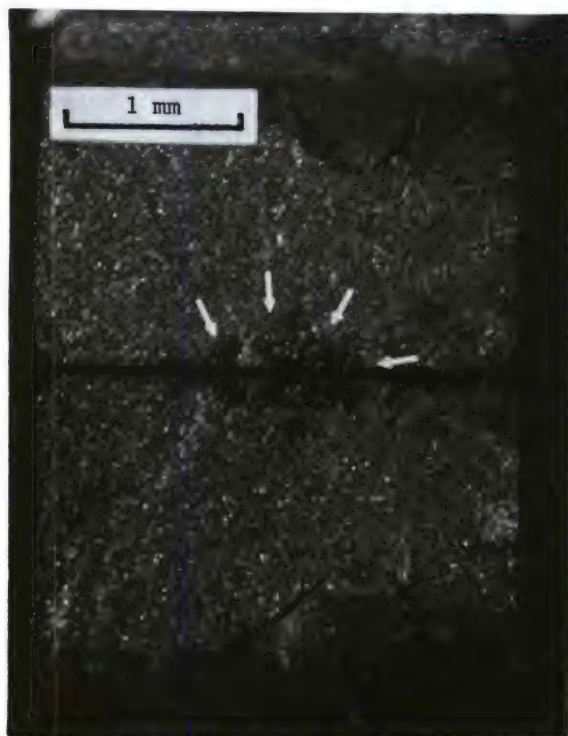
Figure 141. Fracture surfaces of an NC 435 STSR sample that failed at 5.5 hours at 1100 C. The white arrows outline the slow crack growth zone in one half. The two fracture halves share their tensile edges.

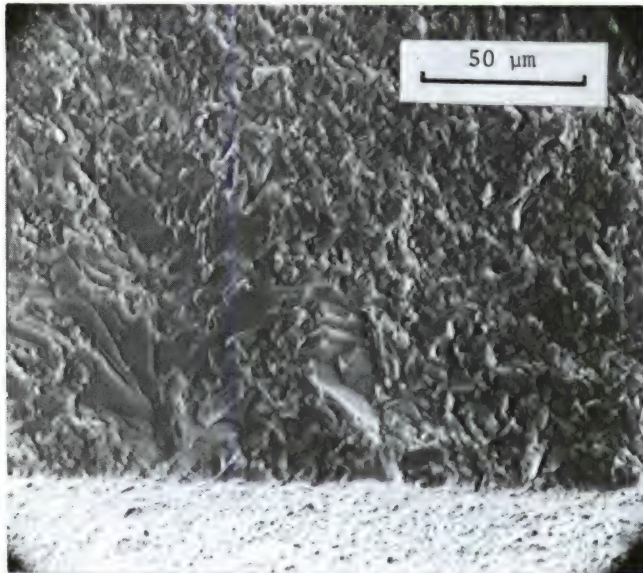
Figure 144. SEM photo of the fracture initiation site of a Silcomp CRC control sample which failed at 455 MPa.

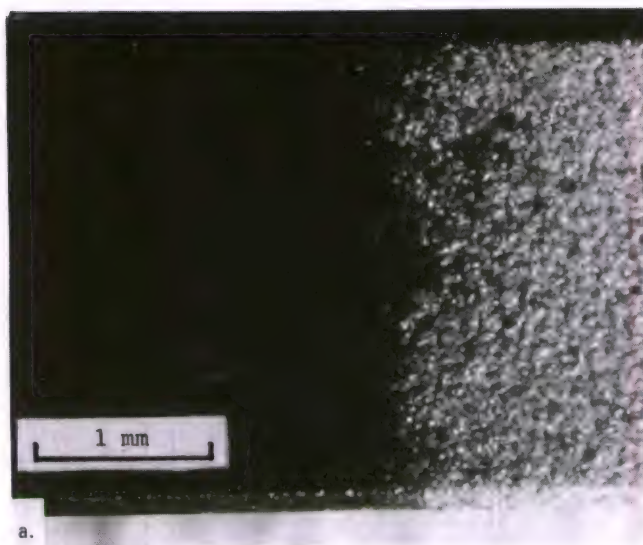
Figure 146. (a) Light photo micrograph of the tensile face of Silcomp CRC bend bar that survived 300 hours intact. A sharp gradient in the oxide layer is evident; (b) SEM close-up of the transition zone. The oxide is coherent and smooth at one end of the sample, but is porous, platelike, and irregular at the other end; (c) close-up of an interrupted zone of the otherwise smooth portion of oxide layer on the surface. A porous zone associated with fiber clump is likely underneath.

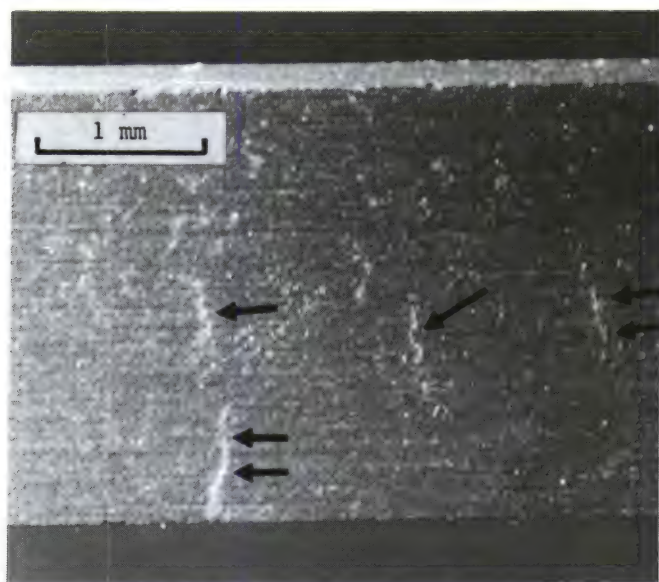
Figure 148. Tensile face of Silcomp CRC STSR sample which failed at 1300 C. Lateral cracks (arrows) run perpendicular to the applied tensile stress. Failure occurred from such a crack.

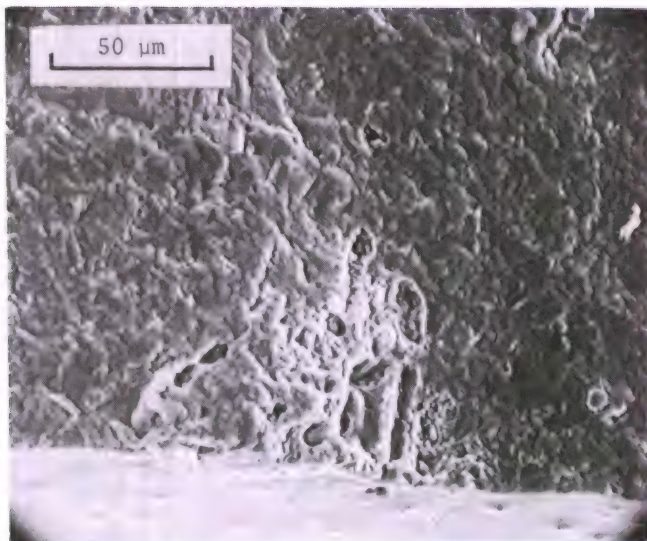
Figure 150. Strength-controlling flaw on a Silcomp CRC STSR survivor. Retained strength was 249 MPa. Sample was loaded to 138 MPa during the STSR test.

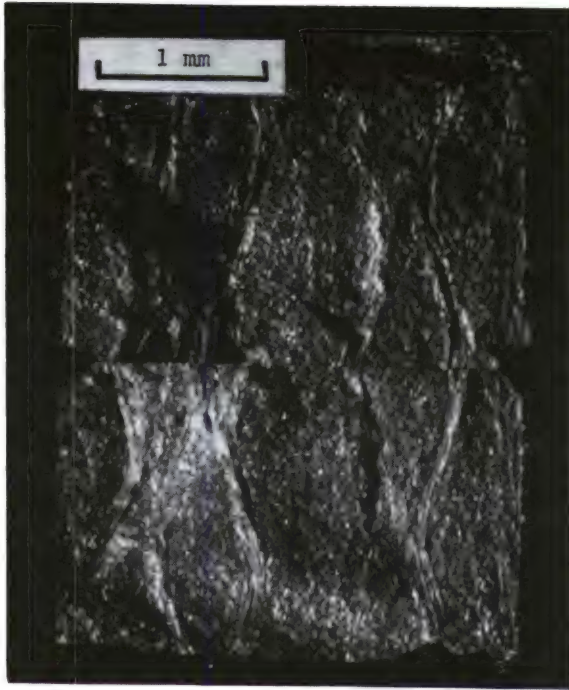
Figure 152. Back-to-back (along tensile edge) matching fracture surfaces of a Silcomp CC sample which failed on loading for a stress rupture trial.
